Manhole Inspection Summary

Manhole # S49I__005MH

Location Address: **rear 512 s glover st**

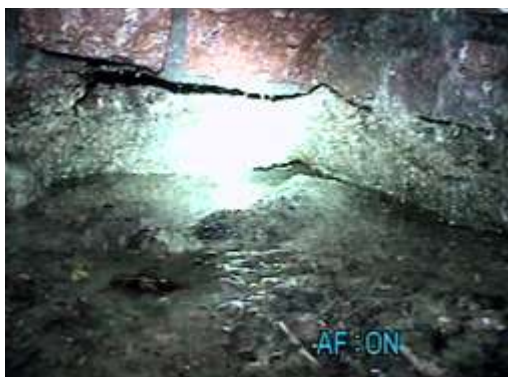
Defect 3

Condition: ☐ Sound ☐ Cracked ☐ Root Intrusion ☐ Loose Brick ☒ **Deteriorated**

hole in barrel

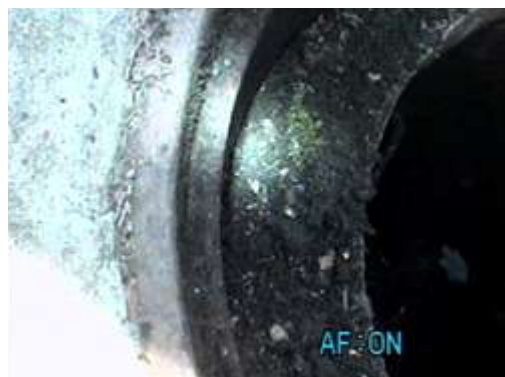
Defect 2

Frame Offset: **6** (in.) Condition: ☒ Sound ☐ Cracked ☐ Leaks

offset

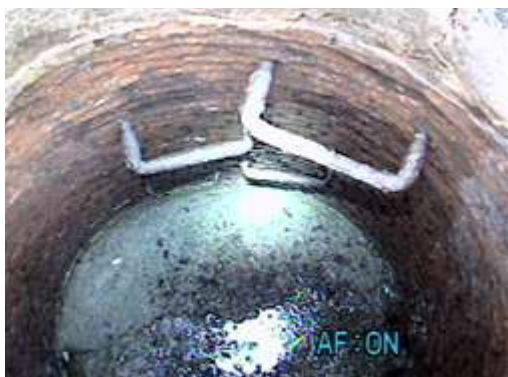
Defect 1

Steps Count: **4** Missing: **1** ☒ **Corroded**

cor. steps

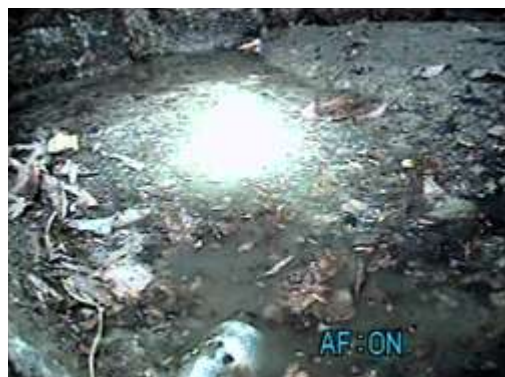
Defect 4

Condition: ☐ Sound ☐ Cracked ☐ Root Intrusion ☐ Deteriorated ☐ Leaks ☒ **Debris**

channel debris

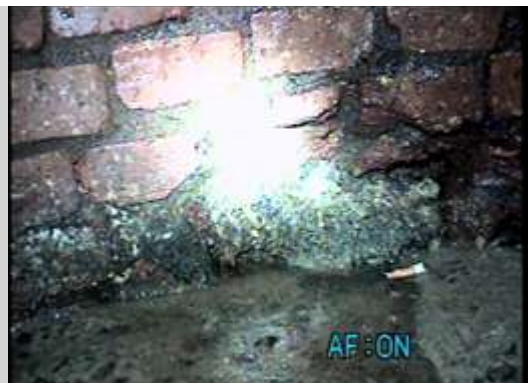
5 O'Clock Inflow

under poo

Infiltration: **Evidence** Pipe Seal Cond: **Unknown**
